# Manhole Inspection Summary

Manhole # S41G\_\_008MH

Insp Date: **5/19/08 10:57 AM**

**Location** Address: **202 lloyd st**

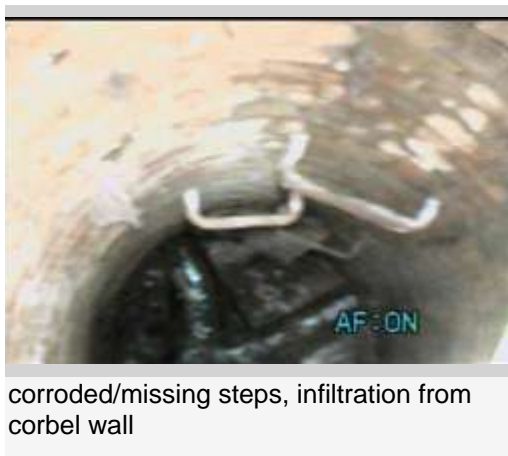
Defect 2

Infiltration: ☐ None ☐ Joint ☐ Cracks ☐ Mortar ☐ Roots ☒ **Wall**

Count: **6** Missing: **1** ☒ **Corroded**

corroded/missing steps, infiltration from corbel wall

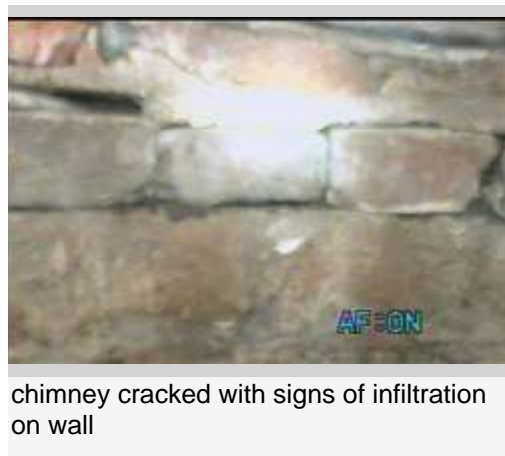
Defect 1

Condition: ☐ Sound ☒ **Cracked** ☐ Root Intrusion ☐ Loose Brick ☐ Deteriorated

Infiltration: ☐ None ☐ Joint ☐ Cracks ☐ Mortar ☐ Roots ☒ **Wall**

chimney cracked with signs of infiltration on wall

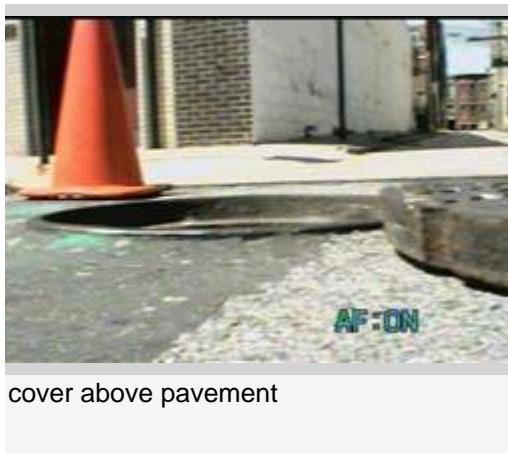
Defect

Diameter: **25.** (in.) Length: **0** (in.) Dist A/B Grade: **1** (in.)  
**5**

cover above pavement
